**MARYLAND HISTORICAL TRUST
DETERMINATION OF ELIGIBILITY FORM**

Maryland Inventory of Historic Properties Form

historic Shriner-Snyder-Ridinger Farm

street and number 2061 Feeser Road not for publication

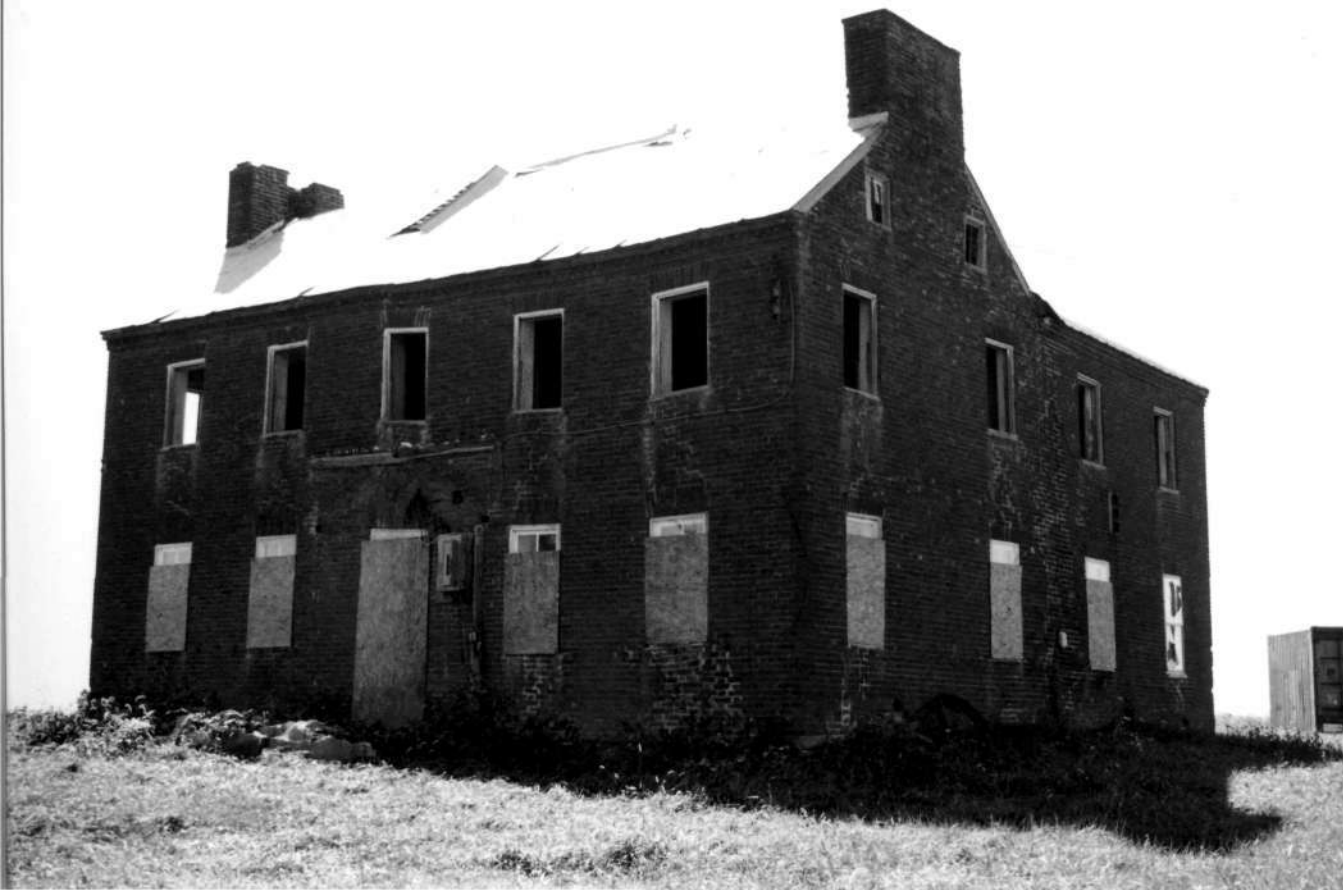
1/6

The northeast elevation has had some major reworking of the foundation with concrete and there is major settlement on this wall. There are two small openings with splayed brick jack arches in the north and north-center bays, but the openings have been altered. The northeast elevation has Flemish bond brickwork with narrow joints and traces of penciling. The first story has a center entrance with a six-panel door that has ogee panel moulds and a boarded-up transom. The door frame has a double bead. There is a sandstone sill that appears to have a wash but is badly spalled, and a splayed brick jack arch. There is evidence of a one-bay porch here. The windows have two-over-two double hung sash with thin wood sills and new concrete underneath of the sills. There is no evidence of pegs in these window frames. There are wrought iron shutter dogs that are flat at the top with a small curl here and are pointed on the bottom. The second story has five two-over-two sash. The cornice has a projecting header course at the bottom, a dogtooth course above it, a stretcher course flush with the forward corners of the dogtooth bricks, and a projecting header course at the top.

The northwest elevation has a brick arch near the north corner of the foundation, but the opening is now filled in. Holes in the brick work around the arch suggest that there was a roof here. The wall is of 4-to-1 common bond. The first and second stories each have two window openings. The first story has two-over-two double hung sash that are boarded-over but have bull nose moulded frames and pegs, or holes for them, at all four corners. The second story sash is missing. The windows have splayed brick jack arches. The gable end has two four-light sash and tapered rake boards.

House- NE & NW elevs

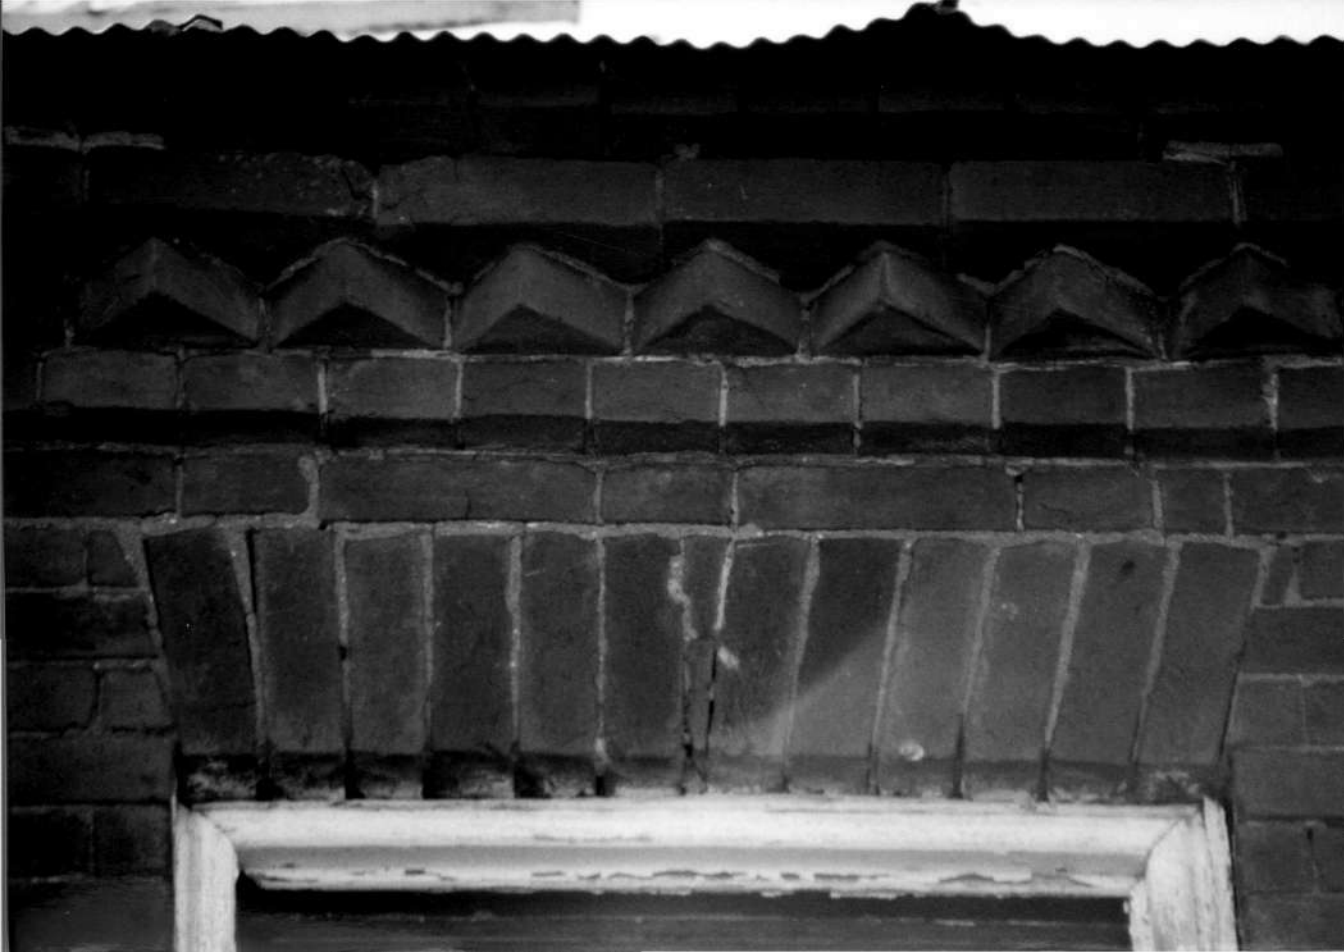
2/6

House- NE ebu cornice

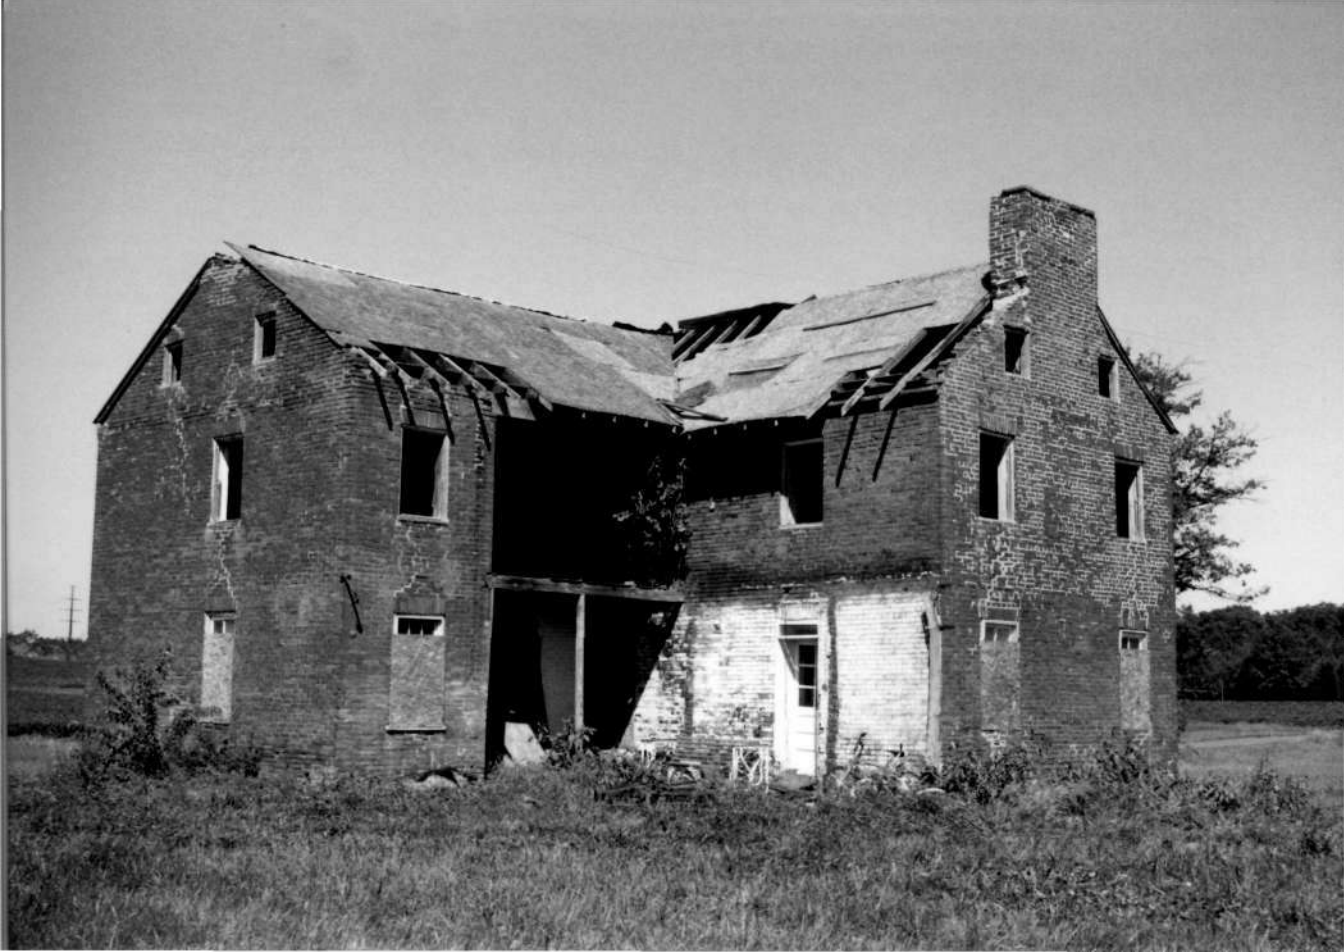
3/6

The southwest elevation of the main block has a doorway in the center bay and a doorway in what appears to be a converted window opening in the east bay. The east bay door has six lights over three lying panels, has a very narrow transom, and a splayed brick jack arch. The first story of the ell under the porch and of the entire southwest elevation of the main block is painted white and there are ghosts of some kind of shed roof here at one time. The second story has a window opening in the east bay. The southeast elevation of the main block has two typical two-over-two sash on the first story, two window openings that are missing

House- SW & SE elevs

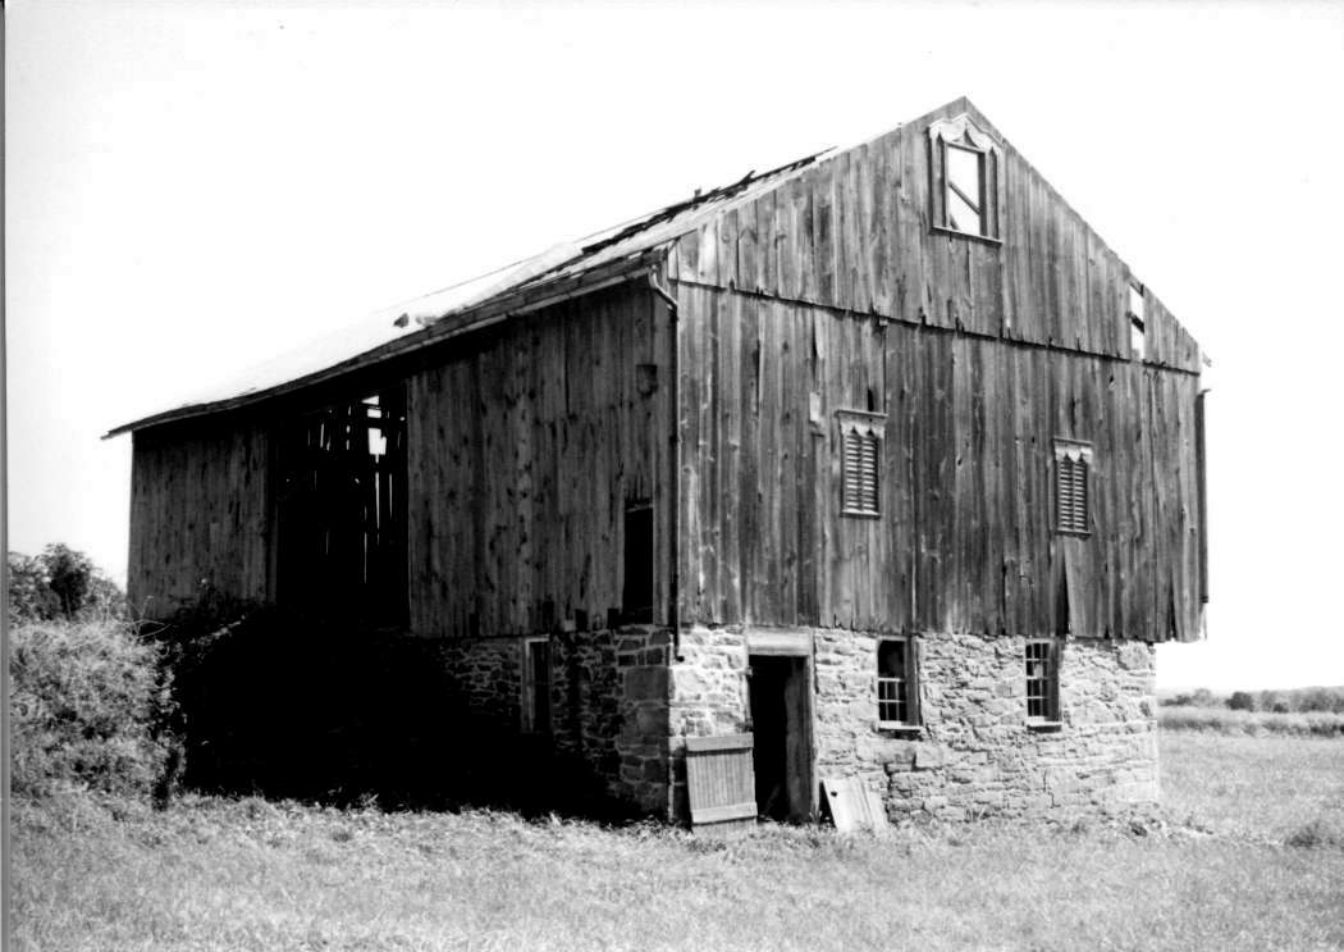
4/6

There is a bank barn located about 200 feet northeast of the house, and the road curves around the barn. It is a two-story, two-bay by five-bay structure with a ramp on the northwest and a cantilevered forebay on the southeast. The lower story is rubble stone consisting of the local brownstone, and the upper story has vertical-board siding. The gabled roof has a northeast-southwest ridge and has corrugated metal roofing, approximately half of which is now gone. The barn is 56 feet, 4- $\frac{1}{2}$ inches long by 28 feet, 4- $\frac{1}{2}$ inches wide on the lower story and has a 4 foot overshoot. The northwest elevation lower story has a window opening with mitered architrave just north of the ramp, and it appears to be added later. The west ramp wall is rubble stone, while the north ramp wall is poured concrete. West of the ramp is a window opening with the remains of a six-over-six sash. The upper story has an opening in the center for a pair of wagon doors that are now gone, but were hung on rollers. On the southwest elevation, the lower story has a Dutch door set to the west with beaded-edge-and-center vertical boards, and "T" hinges. Above the door is horizontal beaded-edge-and-center boards used as infill below the lintel. To the south of this door are two six-over-six double-hung sash in mitered frames. The upper story has two double vents with jig-sawn trim, and there is a large vent in the gable peak that also has jig sawn trim of a different pattern. It is not possible to tell whether the center of the vent had louvers or a window sash. The vent is tripartite, with both sides being filled with siding rather than louvers or sash. The lower story of the southeast elevation has six typical Dutch doors like that on the southwest elevation, with two typical six-over-six sash. The windows are set in the second bay in from each end. The upper story has a large door of beaded-edge-and-center vertical boards hung on rollers in the center bay, with two typical vents to each side. The northeast elevation has three typical six-over-six sash on the lower story and two typical vents on the upper story with a gable end opening that matches the southwest gable end. There are the remains of what was a six-over-six sash in the gable peak.

Barn- NW & SW elevs

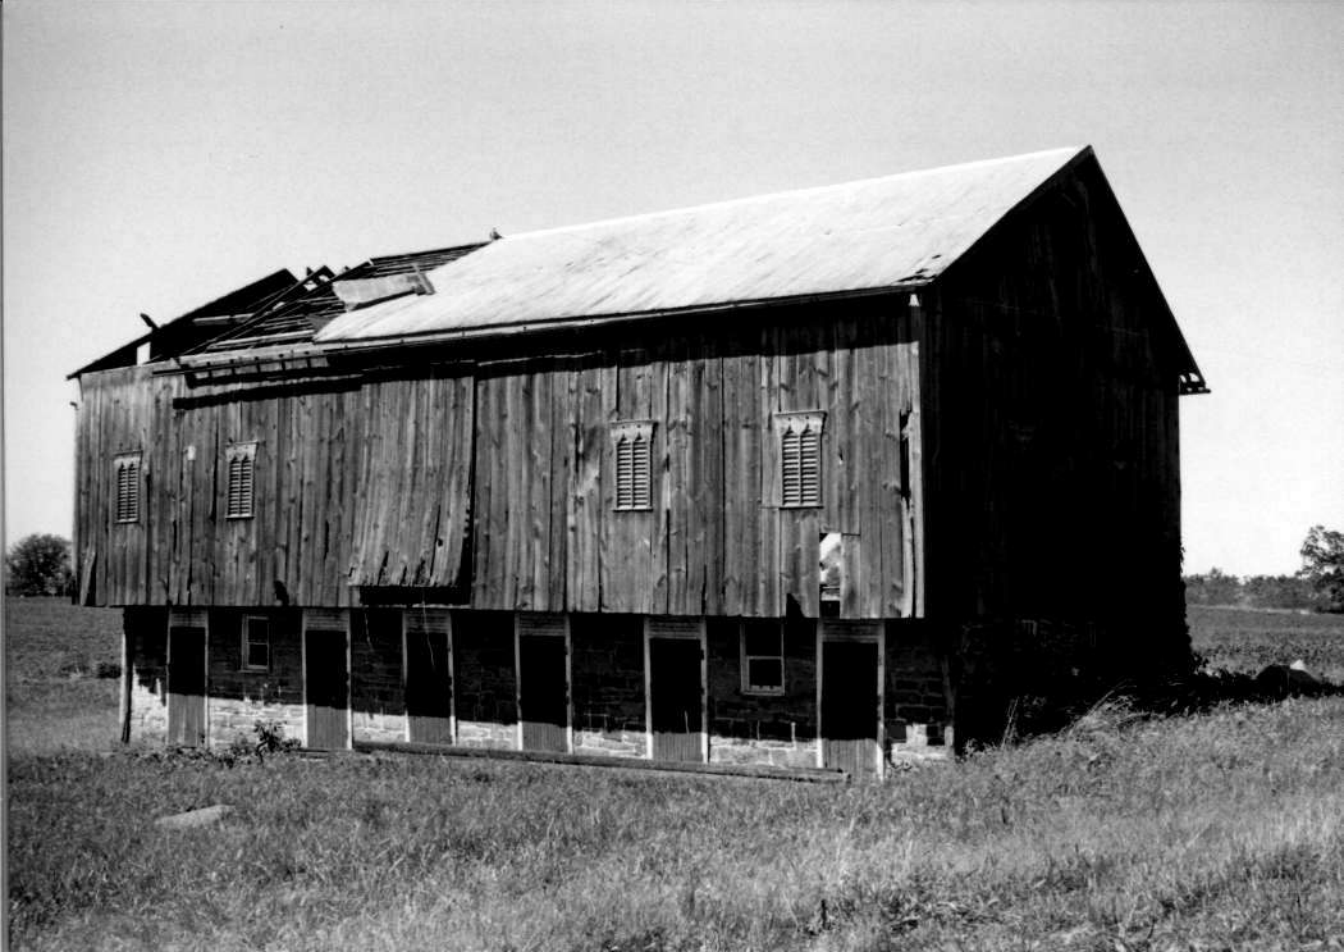
5/6

Barn SE & SW eaves

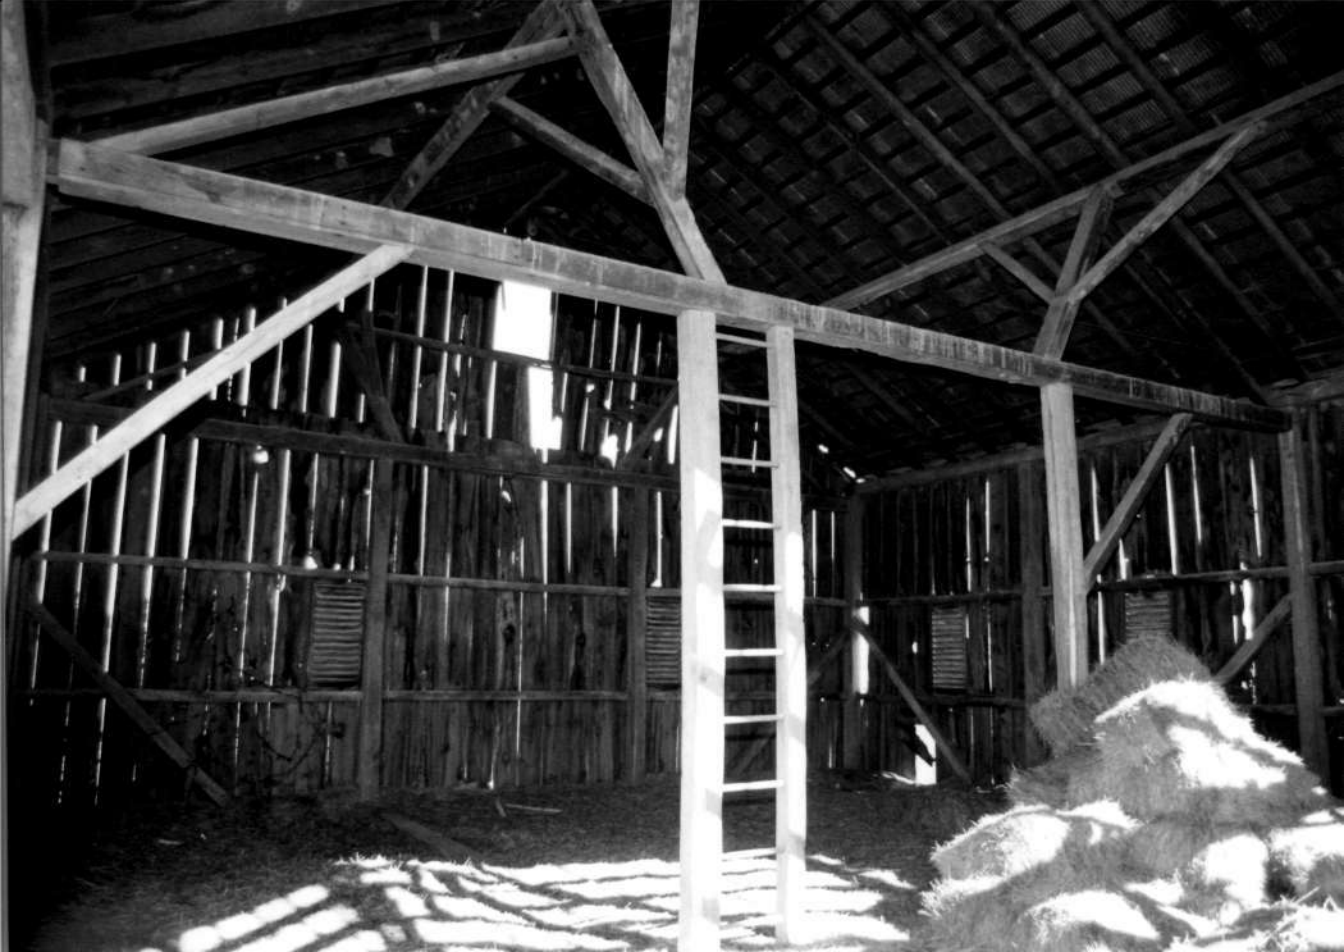
6/6

The upper story has a center threshing floor with one hay mow to each side. There is a granary in the west corner that has three bins. The barn has four bents of circular-sawn heavy timber framing that consist of small dimensional lumber that has 1-inch-thick boards nailed to both sides and the bottom in order to make them larger. The boards are fastened with wire nails. The boards on the bottom of the girts have a tenon cut on the end to mirror the tenon on the girt, and the locations of the boards indicate that this is the original construction and not pieces scabbed on for later support. The corner posts and door bent posts have down braces in the plane of the wall only. The rafters are approximately 2 inches by 8 inches, are mitered at the ridge, and support widely-spaced lath. The purlins have half-lap scarfs with one visible face peg. The plates have beveled half-lap scarfs, also with one visible face peg. The purlins are supported by great struts or purlin posts, portions of which are nailed rather than pegged. There is a hay track in the ridge.

Barn interior - vw. NE
